## Executive Summary

The following report is the result of a site visit by Mark C. Spielbauer of Hoffman PD&C that occurred on August 18, 2022. Site observations, construction plan reviews, and interviews with staff were all used in the preparation of this report.

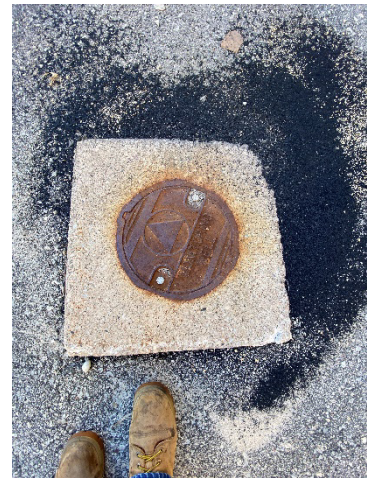
During the site assessment, it was noted that several labeled monitoring wells existed across the site. The owner was unaware of the presence of the wells or any reason for their presence

Monitoring well east side of school

1. A further evaluation of the north side concessions building should be done.
2. Further research would be required to determine the reason for the installation of the noted monitoring wells east and west of the buildings.
